**Kissing Tree  
Master  
*San Marcos , TX***

Report #: 40052-1  
Beginning: January 1, 2024  
Expires: December 31, 2024

**RESERVE STUDY  
Update "With-Site-Visit"**

May 2, 2024

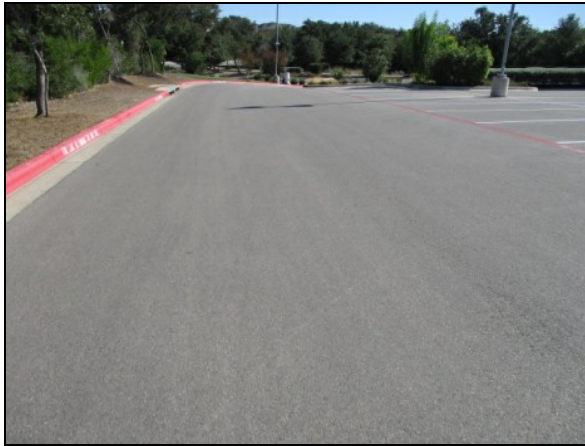
Useful Life:  
25 years

Remaining Life:  
19 years

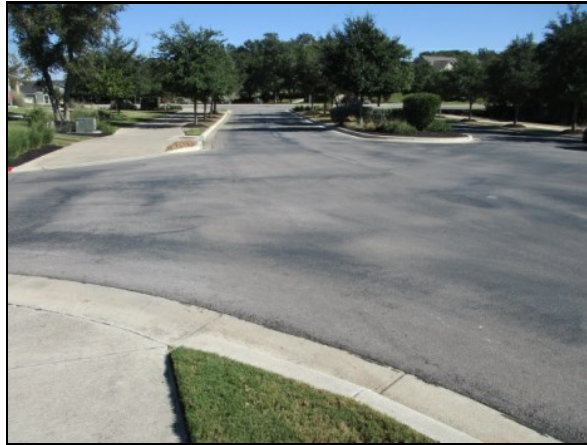
Useful Life:  
25 years

Remaining Life:  
18 years

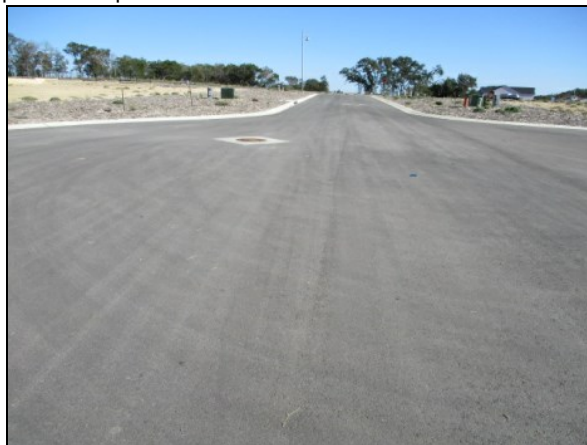
Useful Life:  
25 years

Remaining Life:  
23 years

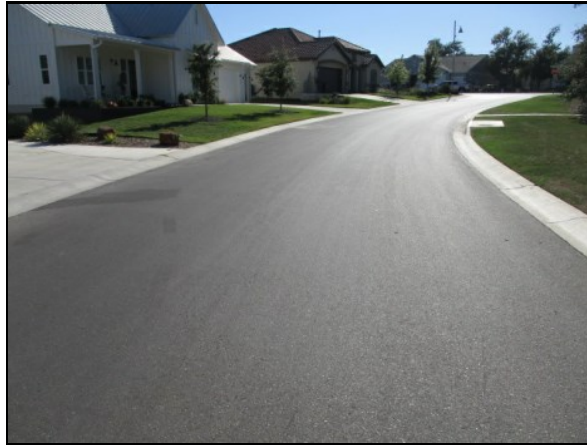
Useful Life:  
25 years

Remaining Life:  
19 years

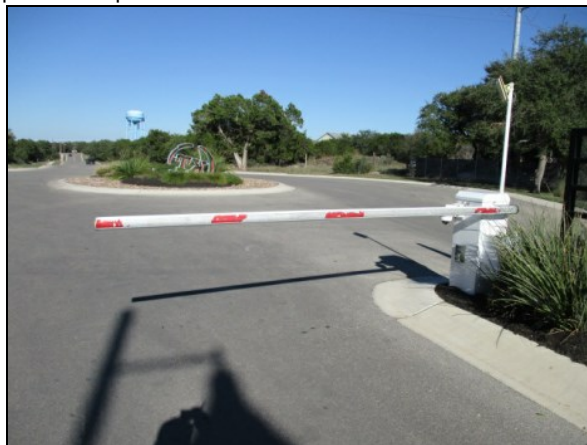
Useful Life:  
25 years

Remaining Life:  
20 years

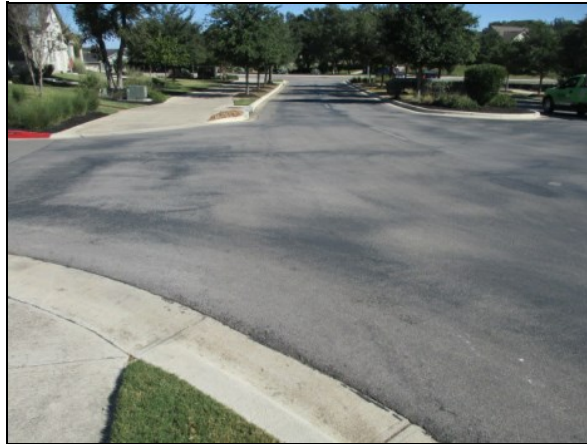
Useful Life:  
1 years

Remaining Life:  
0 years

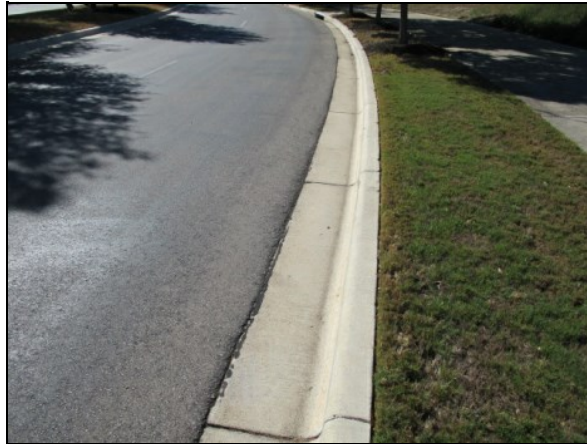
Useful Life:  
5 years

Remaining Life:  
15 years

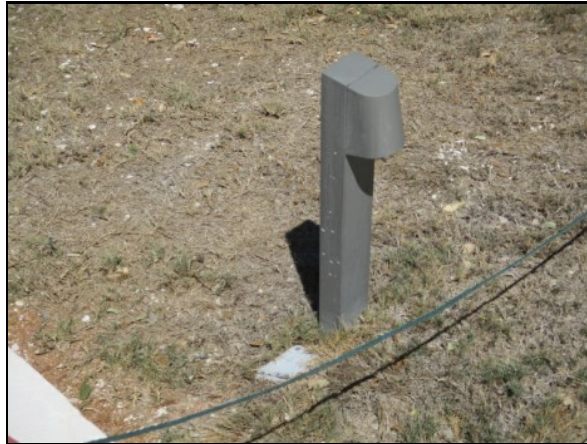
Useful Life:  
15 years

Remaining Life:  
9 years

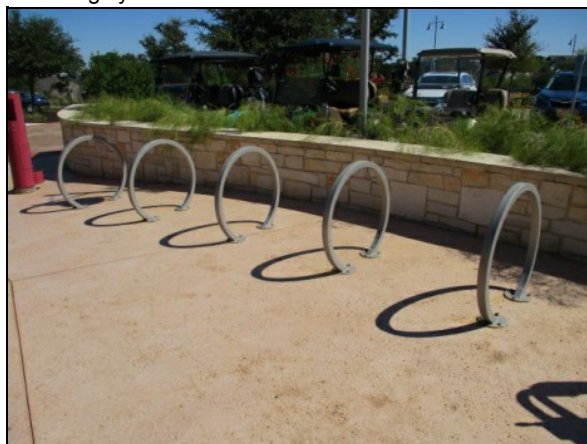
Useful Life:  
20 years

Remaining Life:  
14 years

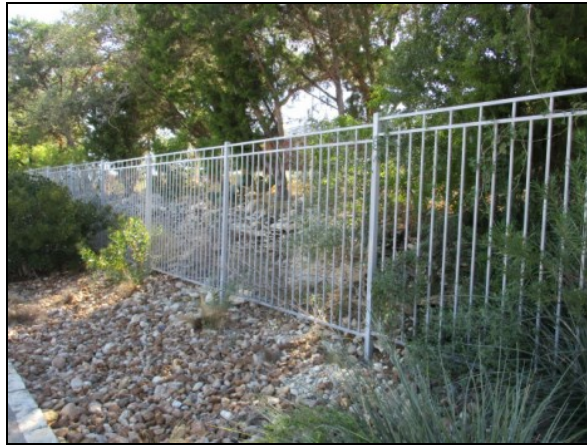
Useful Life:  
5 years

Remaining Life:  
15 years

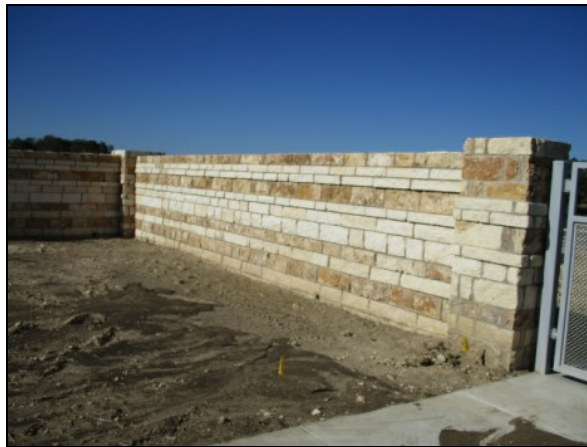
Useful Life:  
10 years

Remaining Life:  
10 years

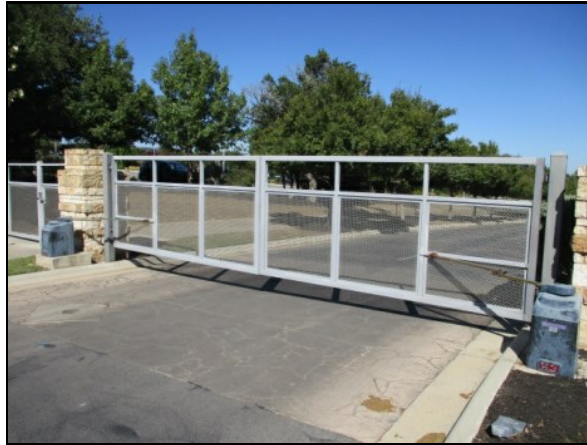
Useful Life:  
25 years

Remaining Life:  
20 years

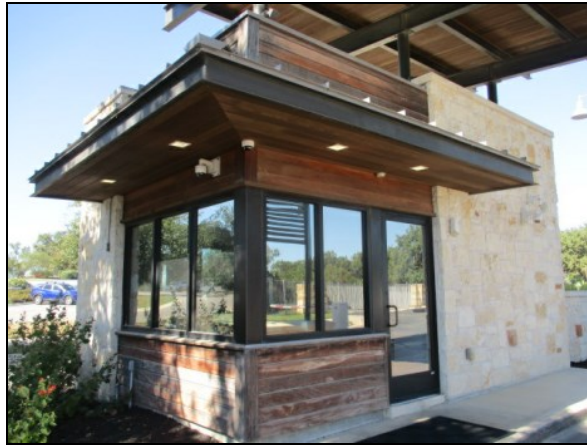
Useful Life:  
25 years

Remaining Life:  
17 years

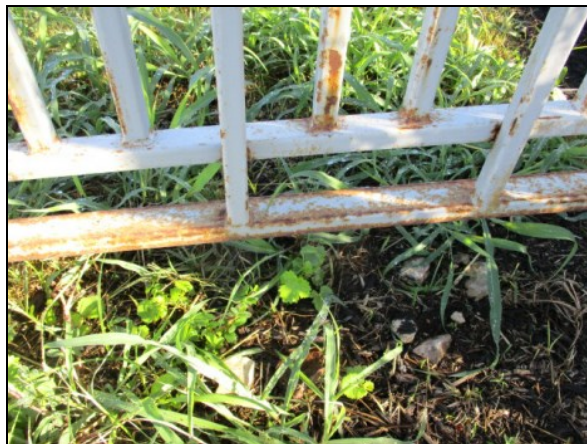
Useful Life:  
1 years

Remaining Life:  
0 years

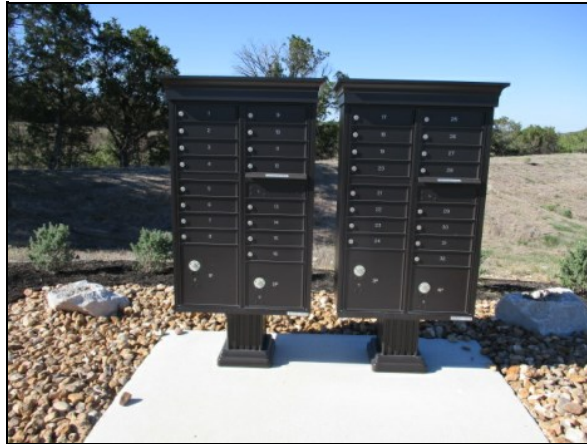
Useful Life:  
5 years

Remaining Life:  
15 years

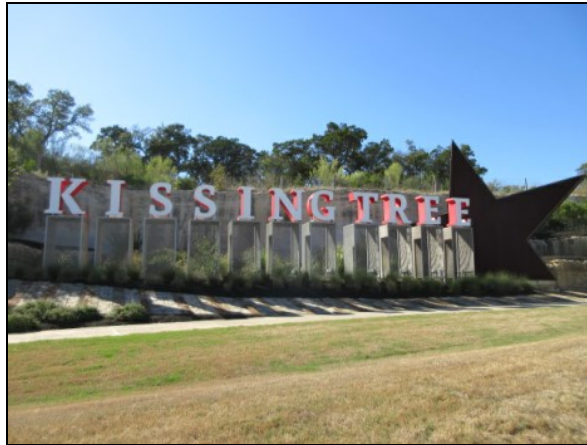
Useful Life:  
30 years

Remaining Life:  
23 years

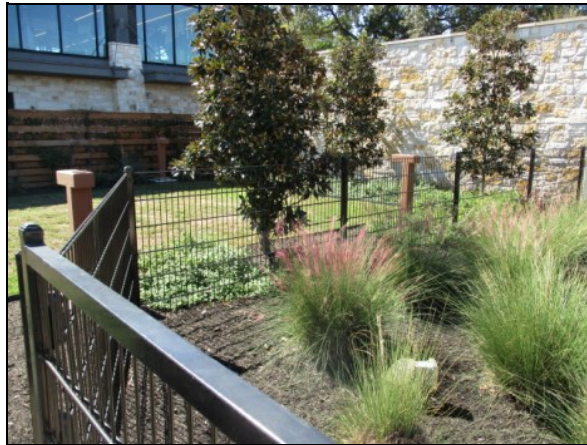
Useful Life:  
5 years

Remaining Life:  
4 years

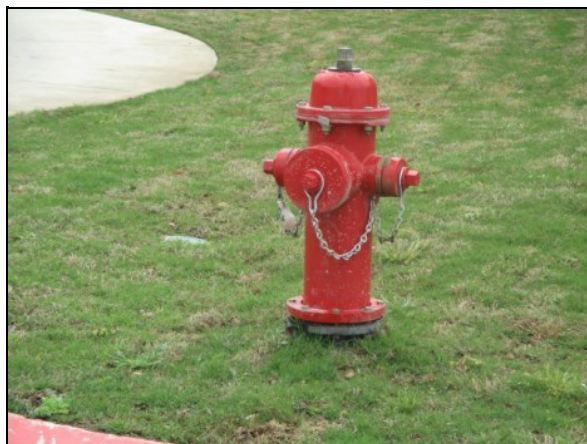
Useful Life:  
50 years

Remaining Life:  
46 years
