**Kissing Tree  
Master  
*San Marcos , TX***

Report #: 40052-1  
Beginning: January 1, 2024  
Expires: December 31, 2024

**RESERVE STUDY  
Update "With-Site-Visit"**

May 2, 2024

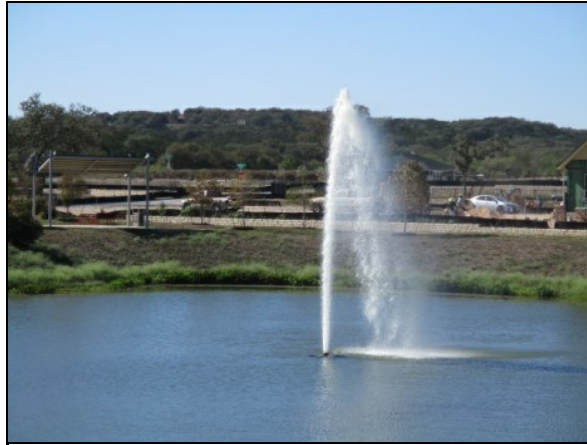
**Comp #: 1702 Pond Fountain - Replace**

Comments: Good condition: Water features determined to be in good condition typically exhibit smooth, attractive interior surfaces with no significant surface wear, cracking, chipping, etc. Any trim sections and décor elements are in good, attractive condition. If present, features such as lighting, jets, fountains, etc. are observed or reported to be in good operating condition.

All water features should be inspected routinely for leaks and mechanical problems. This component represents a general allowance for inspection, waterproofing, repair/refurbishment, etc. Interior finishes should be regularly cleaned and sealed to ensure good appearance and watertight surface. Repairs/replacement of drains, lighting, pumps, filters, etc. should be included as needed.

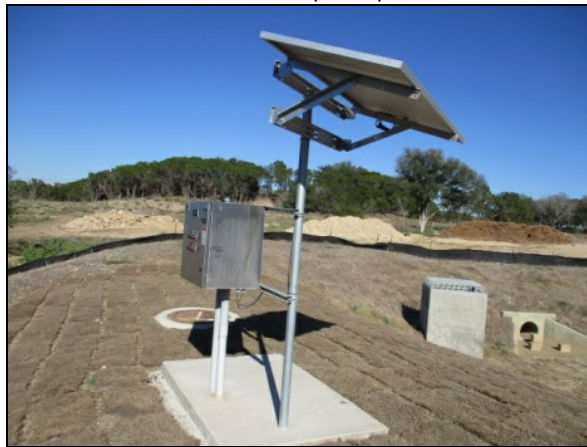
**Comp #: 1708 Batch Detention Equip. - Replace**

History: (2) Pond valve motors replaced in 2023 for \$8,000, 8 valve extensions and 4 valves installed in 2023 for \$36,000

Comments: Funding provided to replace 50% of the equipment following the schedule below.

Minimal or no subjective/aesthetic value for this component. Useful life is based primarily on normal expectations for service/performance life in this location. Unless otherwise noted, remaining useful life expectancy is based primarily on original installation or last replacement/purchase date, our experience with similar systems/components, and assuming normal amount of usage and good preventive maintenance.

No access to directly inspect pumps to verify sizes. Make sure to inspect, test and repair as needed as an operating expense to ensure maximum design life and optimize performance. Pump motors can typically be replaced as-needed through this component or the operating budget. At longer intervals, lift station pumps and controllers should ideally be replaced all together as one packaged system to optimize performance. Life span can vary depending on level of use, but plan to replace at the approximate interval shown below. Cost allowances shown below assume repair/replacement with similar materials that are currently in place.

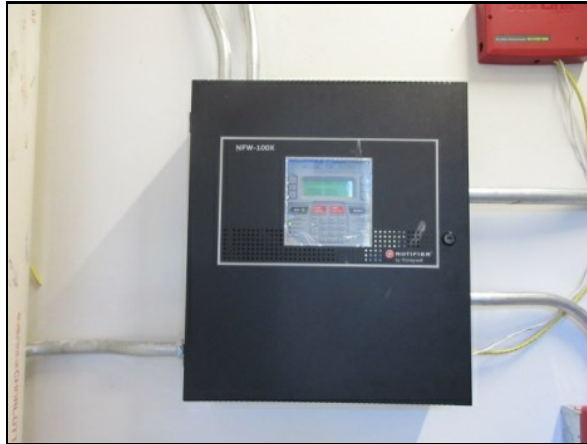
**Comp #: 1803 Fire and Life Safety Sys. - Replace**

Our inspection is for planning and budgeting purposes only; fire alarm equipment is assumed to have been designed and installed properly and is assumed to comply with all relevant building codes. Regular testing and inspections should be conducted as an Operating expense. In many cases, manufacturers discontinue support of equipment after a certain number of years, which may limit availability of replacement parts as the system ages. Cost estimates assume that existing wiring can be re-used and that only panel and devices will be replaced. If wiring requires replacement, estimates should be increased accordingly, but in our experience wiring should have an indefinite useful life. Cost estimates are based on quantity and type of existing equipment, not including any expansion or upgrades, which may be required. We recommend reviewing system components with fire alarm vendor on a regular basis. If expansion of system is found to be required, the Reserve Study should be updated and any additional costs should be factored accordingly.

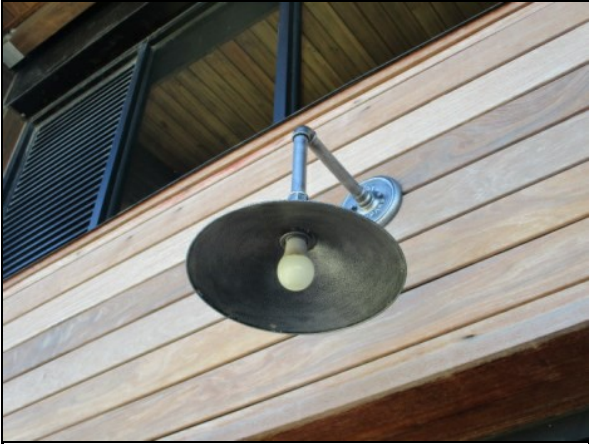
**Comp #: 356 Lighting: Exterior - Replace**

Comments: Good condition: Exterior lights determined to be in good condition typically exhibit only minor signs of normal wear and tear and are consistent with local aesthetic standards for the development.

Observed during daylight hours but assumed to be in functional, operating condition. As routine maintenance, clean by wiping down with an appropriate cleaner, change bulbs and repair as needed. Individual replacements should be considered an Operating expense. If available, an extra supply of replacement fixtures should be kept on-site to allow for prompt individual replacements. Best practice is to plan for total replacement to periodically restore an attractive aesthetic standard within the property's common areas. Based on evident conditions and repair/replacement history provided by the Client during this engagement, we recommend financially preparing for comprehensive replacement at the approximate time frame below. Unless otherwise noted, costs shown here are based on replacement with comparable quantity and style of lights as existing. We recommend consideration of LED fixtures or other energy-saving options whenever possible.

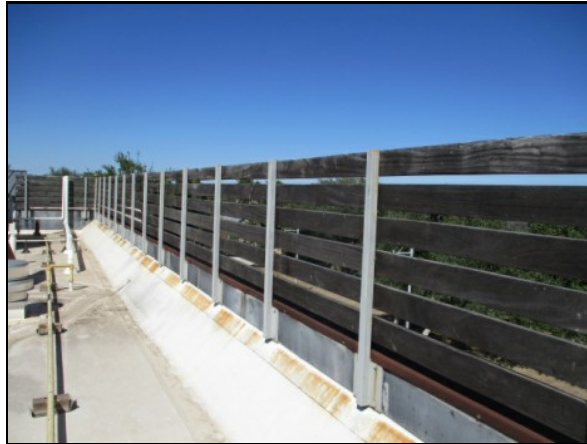
**Comp #: 505 Fencing: Wood - Replace**

Comments: Good condition: Wood fencing determined to be in good physical/structural condition is stable and upright, with no signs or reports of damage or required repairs. All components and hardware appear to be in serviceable condition with no unusual or advanced signs of wear or age. Fencing is in good aesthetic condition.

As routine maintenance, inspect regularly for any damage, repair as needed and avoid contact with ground and surrounding vegetation wherever possible. Regular cycles of uniform, professional sealing/painting will help to maintain appearance and maximize life. In our experience, wood fencing will typically eventually break down due to a combination of sun and weather exposure, which is sometimes exacerbated by other factors such as irrigation overspray, abuse and lack of preventive maintenance. Recommendation and costs shown here are based on replacement with similar style and material. However, the Association might want to consider replacing with more sturdy, lower-maintenance products like composite, vinyl, etc. Although installation costs are higher, total life cycle cost is lower due to less maintenance and longer design life expectancy.

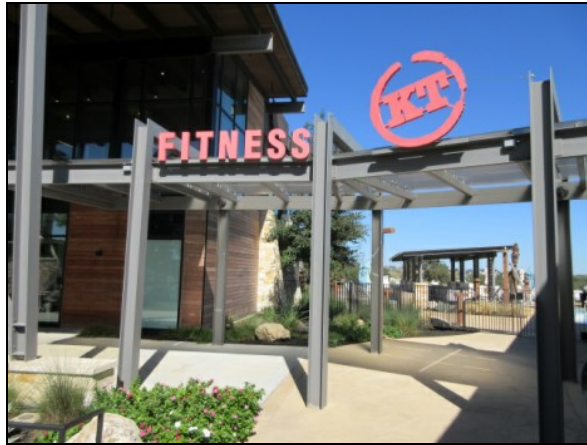
**Comp #: 509 Pergola (Metal/Glass) - Replace**

Comments: Fair condition: Pergola structures determined to be in fair condition typically exhibit more wear and tear, possibly including some warped, split and/or deteriorated components. Framework/structure should still be sturdy but may have sections showing minor leaning or damage.

We strongly recommend regular inspections, maintenance, and repairs as-needed to help prolong useful life cycles. Cost estimates related to this component are not expected to meet the minimum threshold for Reserve funding at this time. As such, costs related to this component are expected to be included in the Client's Operating budget. However, any repair and maintenance or other related expenditures should be tracked, and this component should be re-evaluated during future Reserve Study updates based on most recent information and data available. If deemed appropriate for Reserve funding, component can be included in the funding plan at that time.

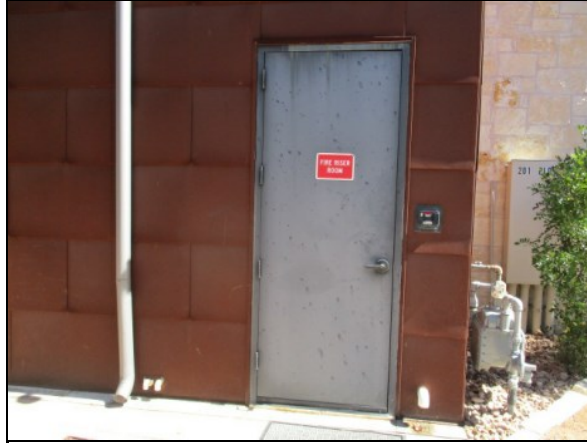
**Comp #: 700 Doors: Utility - Replace**

Comments: Good condition: Utility doors determined to be in good condition typically exhibit minor, normal signs of wear and tear. Frame, hardware and hinges are free from significant rust and corrosion, and doors generally appear to open and close easily.

In general, costs related to this component are expected to be included in the client's operating budget. Therefore, there is no recommendation for reserve funding at this time. However, any significant expenditures related to this component (other than routine maintenance) should be tracked/reported by the client. This component should then be re-evaluated during future reserve study updates based on most recent information and data available at that time. If deemed appropriate for reserve funding, this component can be included in the funding plan at that time.

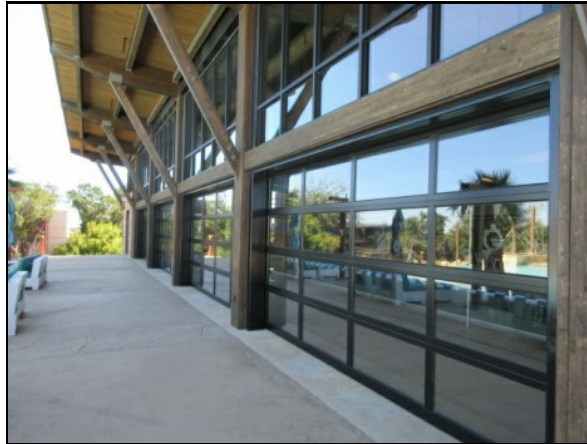
**Comp #: 702 Doors: Garage/Rolling - Replace**

Good condition: Garage doors determined to be in good condition typically exhibit few or no significant signs of wear or deterioration. Appearance is good and upholding aesthetic standards of the development.

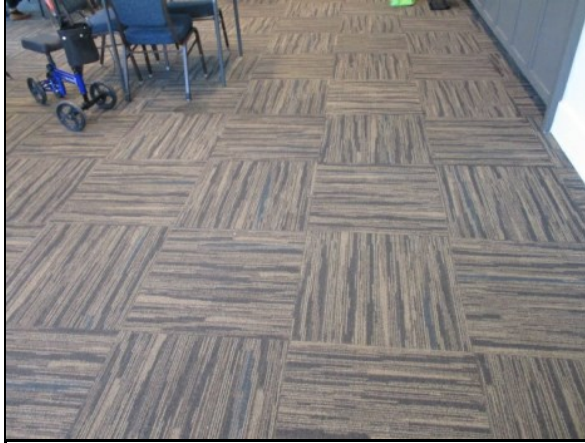
**Comp #: 601 Carpeting - Replace**

Comments: The carpet is in good condition. No significant deterioration observed at this time. Expect a full useful life.

As part of ongoing maintenance program, vacuum regularly and professionally clean as needed. Over time, replacement will be warranted due to excessive wear (stains, fading, discoloration, etc.). Best practice is to coordinate at same time as other interior projects whenever possible to minimize downtime and maintain consistent quality standard. Based on evident conditions, original installation, and project history provided by the Client, we recommend planning for replacement at the approximate interval shown below. Replacement costs can vary greatly depending on quantity, material, and design selected. Unless otherwise noted, cost estimates below assume replacement with similar quantity and quality as existing.

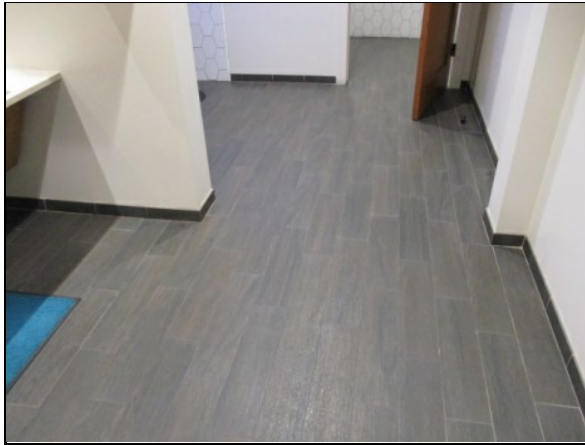
**Comp #: 603 Flooring: Tile - Replace**

Comments: Good condition: Interior tile flooring determined to be in good condition typically exhibits little to no significant wear. Few or no cracks, and style is still appropriate and upholding the aesthetic standards of the property.

As part of ongoing maintenance program, tile should be inspected regularly and damaged sections repaired/replaced as needed. Best practice is to keep a collection of replacement tiles on hand for partial replacements. With ordinary care and maintenance, tile in interior locations can last for an extended period of time, but replacement is often warranted eventually to enhance and restore aesthetic appeal throughout the common areas. Based on evident conditions, original installation, and project history provided by the Client, we recommend planning for replacement at the approximate interval shown below. Replacement costs can vary greatly depending on size, material, and design of tiles selected. Unless otherwise noted, cost estimates below assume replacement with similar quantity and quality as existing.

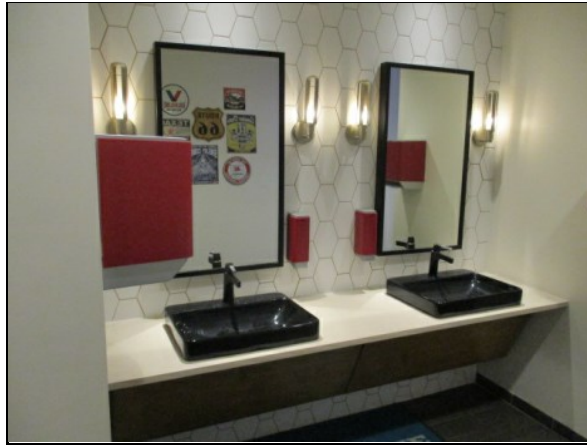
Good condition: Restrooms determined to be in good condition typically exhibit clean, attractive countertops (and cabinetry, if present). Fixtures all appear to be functional and in good aesthetic condition. Flooring and wall finishes show only minor, routine signs of wear and age. Overall, appearance and design aesthetic is good and appropriate for the standards of the community.

As routine maintenance, inspect regularly and perform any needed repairs promptly utilizing general Operating funds. Typical remodeling project can include some or all of the following: replacement of plumbing fixtures, partitions, countertops, lighting, flooring, ventilation fans, accessories, décor, etc. Best practice is to coordinate this project with other amenity areas, such as kitchens or other amenity rooms. Remaining useful life is based on consideration of materials, evident conditions, and/or remodeling/renovation history provided during the engagement. Costs can significantly vary based on an anticipated scope of work as well as materials chosen for remodeling/renovation. Unless otherwise noted, estimates shown are based primarily on light to moderate cosmetic remodeling, not complete "gut" remodel projects.

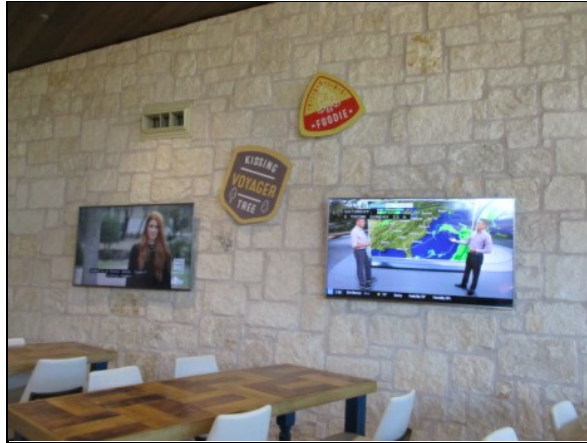
**Comp #: 919 TV's - Replace**

Comments: The TV's are in fair condition. No issues reported. Expect a full useful life.

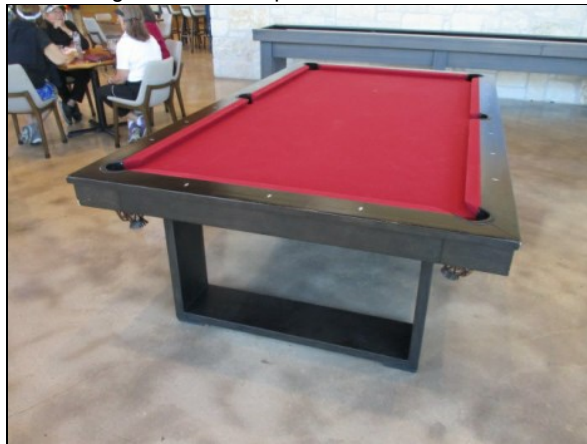
**Comp #: 921 Game Pieces - Replace**

The pieces are in good condition. No damage observed. Expect a full useful life.

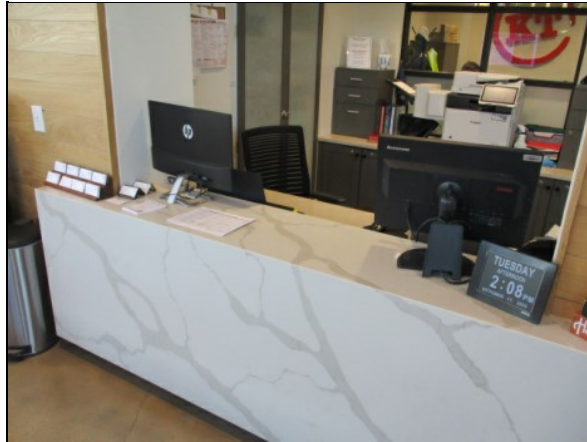
Good condition: Interior fixtures and built in pieces determined to be in good condition typically exhibit little to no signs of physical wear and tear, and style/fixture type is appropriate for the standards of the property.

Light fixtures should be inspected, repaired and bulbs replaced as needed through the Operating budget. Over time, the fixtures will require replacement for either functional or aesthetic reasons. Best practice is to coordinate at same time as other interior projects (especially painting or wallcovering replacement) whenever possible to minimize downtime and maintain consistent aesthetic standard. Timing of replacements is ultimately subjective to the Client. A wide variety of fixture styles is available, and cost can vary significantly based on the fixture chosen for replacement. Unless otherwise noted, cost estimates shown below assume replacement with comparable quality as existing fixtures and are based on our experience with similar properties.

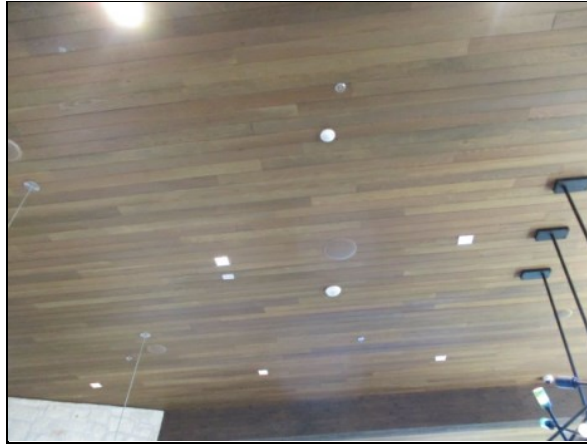
**Comp #: 1110 Interior Surfaces - Repaint/Stain**

Comments: Includes: 4,170 GSF of painted surfaces and 8,620 GSF of stained wood surfaces.

Good condition: Interior areas determined to be in good condition typically exhibit few significant marks, scuffs or other aesthetic concerns. Color is consistent and compatible with other finishes/furnishings and maintaining good standards in the common areas.

Regular cycles of professional painting are recommended to maintain appearance. Small touch-up projects can be conducted as needed as a maintenance expense, but comprehensive painting of interior areas will restore a consistent look and quality to all areas. Best practice is to coordinate at same time as other interior projects (flooring, furnishings, lighting, etc.) whenever possible to minimize downtime and maintain consistent quality standard. Based on evident conditions and/or project history provided during this engagement, we recommend repainting at the approximate interval shown below. Unless otherwise noted, cost estimates below are intended for painting only and not inclusive of any extensive wall repairs/renovations (such as trim work, etc.).

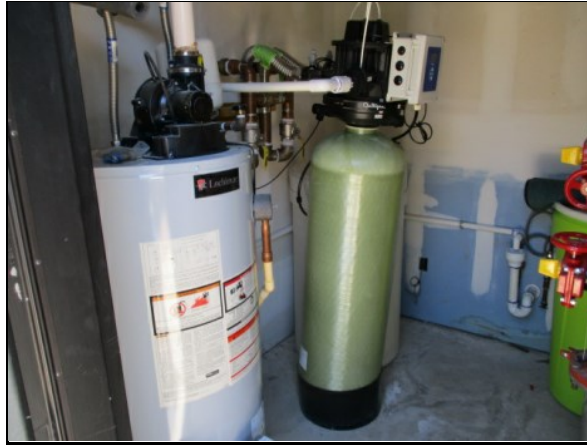
**Comp #: 310 Water Softening System - Replace**

Comments: Water softening system(s) should be inspected regularly and repaired as-needed by a servicing vendor or maintenance staff to ensure proper function. Softening systems generally protect the association against hard water build-up over long periods of time.

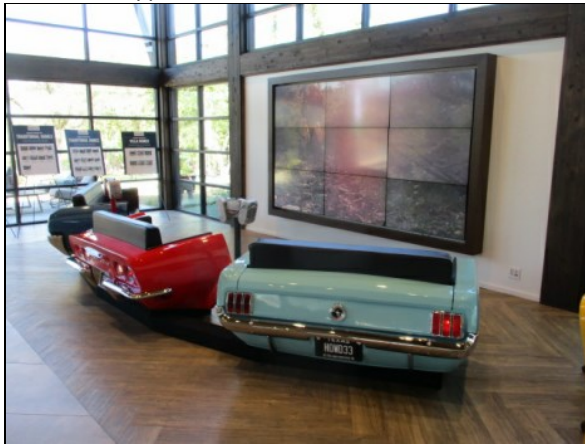
**Comp #: 396 Furniture: Indoor - Replace**

The furniture is in good condition at this time. Normal wear observed. Expect a full useful life. Best to replace all of the pieces at the same time in order to maintain a uniform appearance.

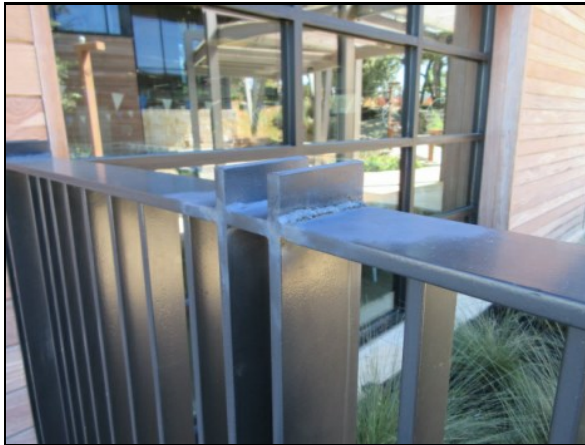
Comments: Good condition: Metal fencing determined to be in good condition typically exhibits a uniform coating or surface finish without any noticeable corrosion or rust. Color and appearance is consistent over most/all areas.

Metal fencing should be painted at the interval shown here in order to inhibit or delay onset of rust/corrosion and prevent or minimize costly repairs. Painting not only protects the metal surface from excessive wear, but promotes a good, attractive appearance in the common areas. Costs can vary greatly depending on existing conditions of fencing, which will dictate amount of repair/prep work required.

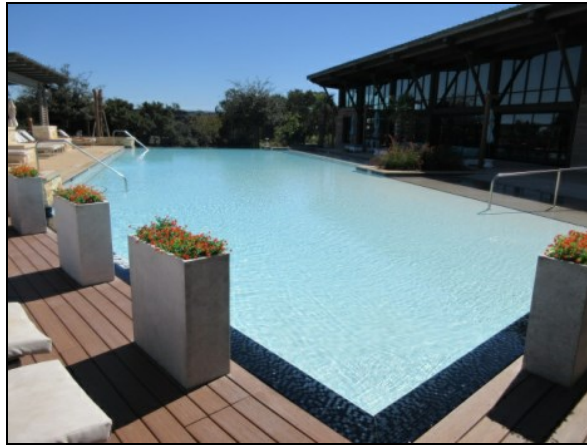
Fair condition: Swimming pools determined to be in fair condition typically exhibit some color fade/discoloration, and roughening of the surface, often more noticeable in the shallow areas and/or at steps. Waterline tiles are in fair condition. Generally believed to be aging normally.

Minor repairs and routine cleaning/maintenance should be considered an Operating expense. Pool resurfacing will restore the aesthetic quality of the pool while protecting the actual concrete shell of the pool from deterioration. This type of project is best suited for slow/offseason to minimize downtime during periods when pool is used heavily. Should be expected at the approximate interval shown below; in some cases, schedule may need to be accelerated due to improper chemical balances or aesthetic preferences of the Client. While drained for resurfacing, any other repairs to lighting, handrails, stairs, ladders, etc. should be conducted as needed.

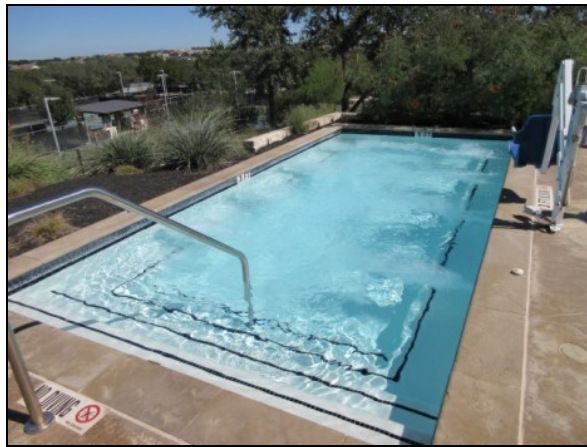
Fair condition: Spas determined to be in fair condition typically exhibit some color fade/discoloration, and roughening of the surface, often more noticeable in the shallow areas and/or at steps. Waterline tiles are in fair condition. Generally believed to be aging normally.

Comparable conditions as noted in prior component details for swimming pool. Resurfacing should be scheduled for the same time.

Minor repairs and routine cleaning/maintenance should be considered an Operating expense. Spas sometimes need to be resurfaced more frequently than pools due to higher chance of chemical imbalances. This type of project is best suited for slow/offseason to minimize downtime during periods when spa is used heavily. Whenever possible, both the pool and spa should be done at the same time to achieve better pricing and minimize downtime. While drained for resurfacing, any other repairs to lighting, handrails, stairs, ladders, etc. should be conducted as needed.

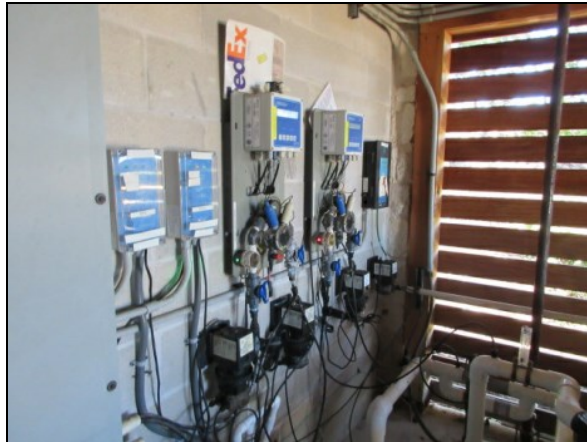
**Comp #: 1209 Chemical Controllers - Replace**

The chemical controllers were not tested during inspection, but are assumed to be functional. No reported issues at this time. Funding has been provided for the periodic replacement of control panels and motors following roughly the schedule below.

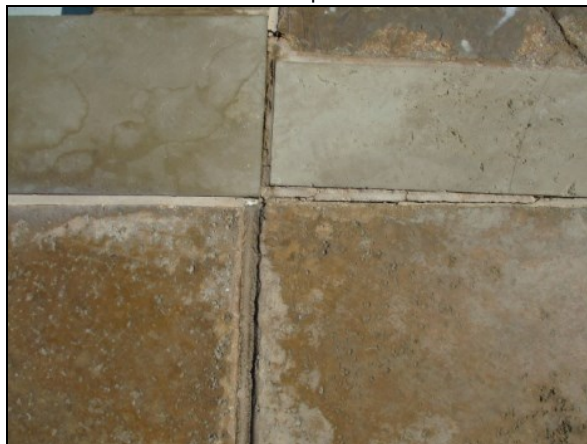
**Comp #: 1214 Pool Mastic - Replace**

Comments: Poor Condition: Pool mastic determined to be in poor condition. There was heavy deterioration on a good portion of the mastic on both the outdoor and indoor pool decks.

Pool decking joints need to be resealed on a regular basis in order to prevent water from penetrating subterranean concrete surfaces and causing decking sloping, cracking, etc. Re-sealing projects should be incorporated with larger pool projects in order to receive better economies of scale and to limit downtime with pool closures.

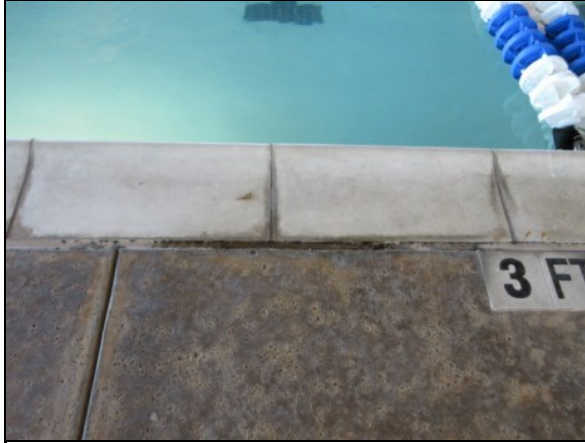
**Comp #: 1215 Pool Coping - Replace**

Comments: Fair Condition: Pool coping was determined to be in fair condition. There is some wear and fading of the coping. There also is some mold buildup along the coping.

Pool coping is generally a long life component that will require minimal maintenance over the years. Pool coping materials and costs can vary, but it is appropriate to fund for eventual replacement of the coping surfaces. Coping areas can develop cracks, which can lift and cause trip hazards. The typical concrete composed materials can often get stained and discolored over time so funding for periodic replacements ensure that aesthetics are met at the pool area. Timing for completion of this project should occur in coordination with every other pool replastering project unless specified here.

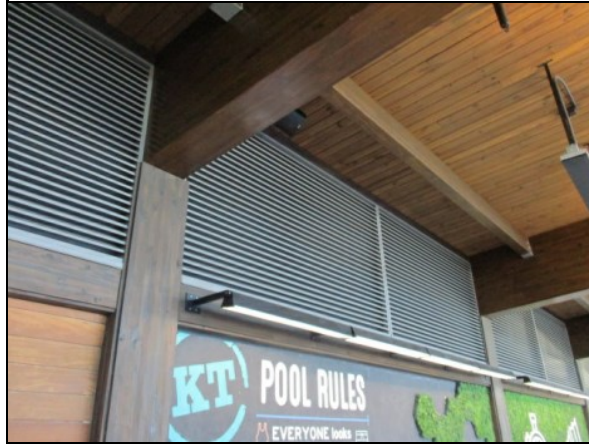
**Comp #: 1850 Window Dampers - Replace**

Comments: The pool dampers were not tested during the inspection but have been reported to be in need of replacement. Best to re-evaluate during future reserve study updates.

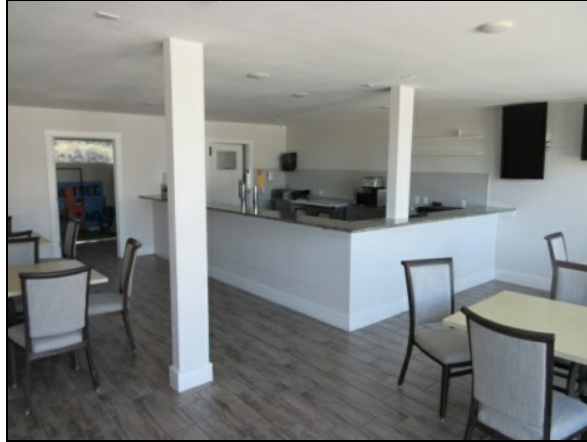
Based on our experience with other associations, remodeling projects typically includes replacement of flooring and other finishes (wall coverings, etc.), as well as painting, and can also include installation/replacement of lighting, counter tops, etc. Costs can vary depending on the type and quality of replacement materials. Funding provided as an allowance for future remodeling efforts.

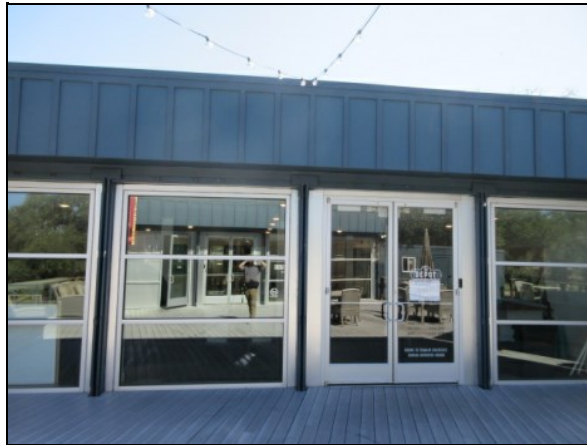
Based on our experience with other associations. Refurbishment typically includes replacement of flooring and other finishes (wall coverings, etc.), as well as painting, and can also include installation/replacement of lighting, counter tops, etc. Costs can vary depending on the type and quality of replacement materials. Best to handle as a general Operating expense. No Reserve funding required.

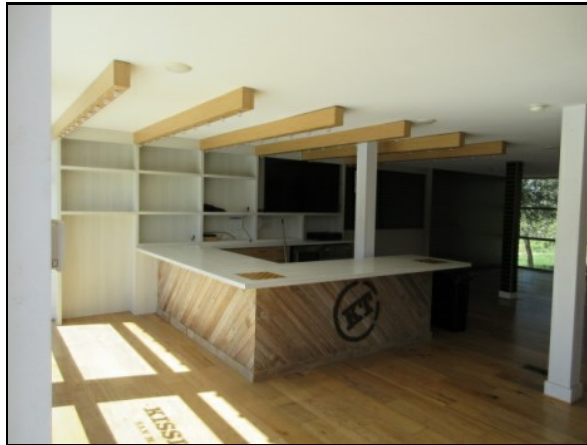
Good condition: Fixtures, furnishings, and equipment (FF&E) determined to be in good condition typically are in good physical condition, and represent an appropriate, consistent aesthetic style for the standards of the property.

Individual fixtures, furnishings, and/or equipment (FF&E) pieces should be repaired/replaced as needed by the Client. Based on evident conditions and/or information provided during this engagement, this component represents a "supplemental" allowance for replacement/refurbishment of interior FF&E in order to maintain a desirable aesthetic in the common areas. Funding also included for interior painting projects. Remaining useful life shown below is based on consideration of asset conditions as well as Client replacement history. Costs of replacement can vary greatly depending the style and quality of replacement options. Best practice is to coordinate this type of project with other interior projects such as flooring replacement, painting, etc. Moving forward, the Client should track and report all replacement expenditures related to this component. This component should then be re-evaluated during future Reserve Study Updates based on the most current information available at that time.

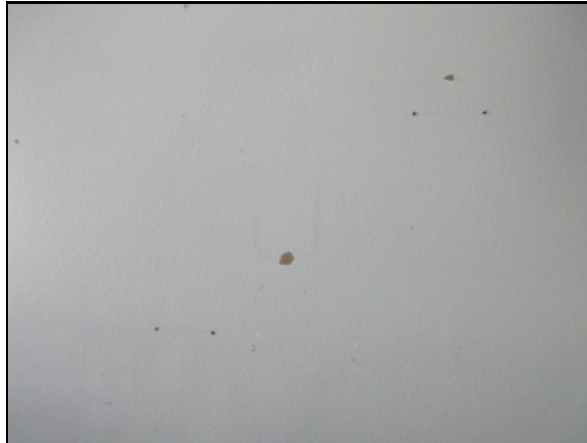
Comments: Fair condition: Interior areas determined to be in fair condition typically exhibit some minor, routine marks and scuffs, small sections of peeling paint, etc. Overall appearance is satisfactory.

Regular cycles of professional painting are recommended to maintain appearance. Small touch-up projects can be conducted as needed as a maintenance expense, but comprehensive painting of interior areas will restore a consistent look and quality to all areas. Best practice is to coordinate at same time as other interior projects (flooring, furnishings, lighting, etc.) whenever possible to minimize downtime and maintain consistent quality standard. Based on evident conditions and/or project history provided during this engagement, we recommend repainting at the approximate interval shown below. Unless otherwise noted, cost estimates below are intended for painting only and not inclusive of any extensive wall repairs/renovations (such as trim work, etc.).

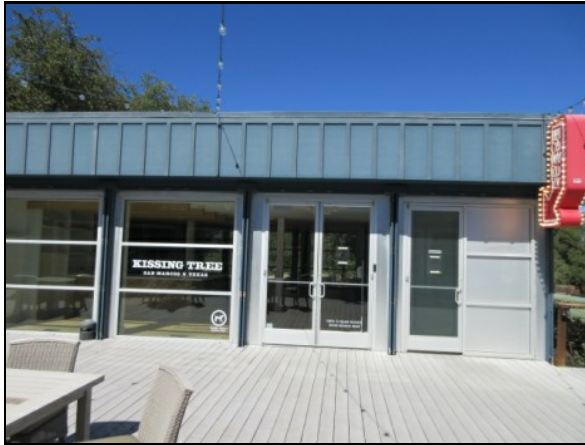
**Comp #: 1128 Fiber Cement Siding - Replace**

Comments: Fair condition: Fiber cement siding/trim sections determined to be in fair condition typically exhibit some color fading and inconsistency, with minor, isolated locations showing more advanced surface wear, cracking, splintering, etc.

Association Reserves does not specifically endorse any products, manufacturers or vendors, but James Hardie Building Products, Inc. is the leading manufacturer of fiber cement siding, and their website ([www.jameshardie.com](http://www.jameshardie.com)) is an informative resource for proper care and maintenance of fiber cement siding. Their "Best Practices" guidelines offer specific guidelines for materials to be used; we strongly recommend complying with recommendations specific to your geographical area. We recommend that the Association consult with qualified exterior painting/waterproofing consultants and/or contractors to ensure that proper materials are used in painting and sealing the building siding.

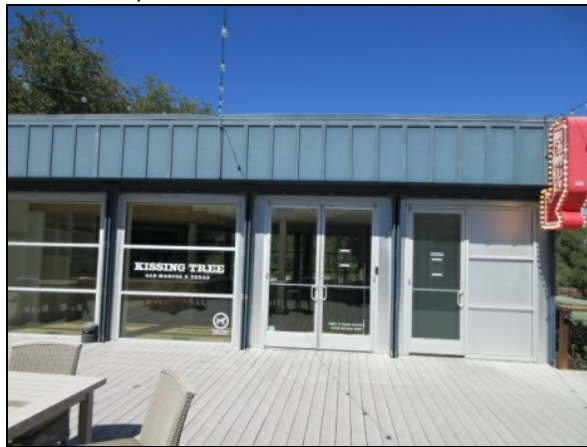
**Comp #: 1319 Metal Roofing - Replace**

Comments: No access to inspect the roofing surfaces. Assumed to be in good condition. No issues reported at the time of the inspection.

Metal roofing is typically a long-lived component assuming it was properly installed and is properly maintained. As routine maintenance, many manufacturers recommend inspections at least twice annually and after large storm events. Promptly replace any damaged/missing sections or conduct any other repair needed to ensure waterproof integrity of roof. We recommend having roof inspected in greater detail (including conditions of sub-surface materials) by an independent roofing consultant prior to replacement. There is a wealth of information available through organizations such as the Roof Consultant Institute <http://www.rci-online.org/> and the National Roofing Contractors Assn. (NRCA) <http://www.nrca.net/>. If the roof has a warranty, be sure to review terms and conduct proper inspections/repairs as needed to keep warranty in force. The timeline for metal roof replacement is generally estimated based on the age of the roof. Remaining useful life can also be adjusted based on inspection of any accessible areas, looking for any damaged or lifting sections, signs of advanced corrosion or wear to panels and hardware, as well as consultation with the Client about history of repairs and preventive maintenance. Advantages of metal roofs include long life expectancies with relatively low need to repair.

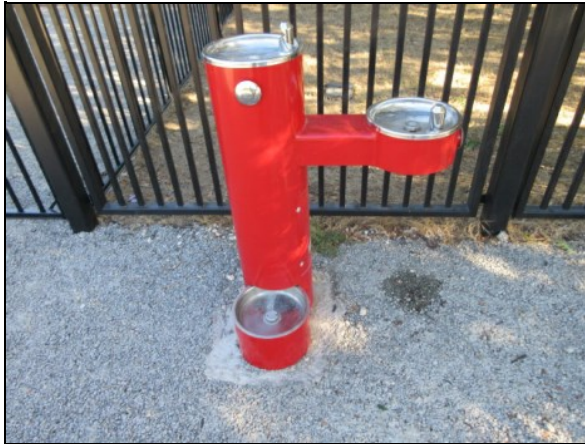
**Comp #: 411 Park Equipment - Replace**

Good condition: Drinking fountains and benches are in good condition. No issues.

Equipment was not tested during site inspection, and is assumed to be functional. Should be cleaned regularly in order to prolong life expectancy. The replacement interval shown below is based upon evident conditions, life expectations based on our experience with similar properties, and aesthetic/functional standards throughout the property's common areas. Unless otherwise noted, cost estimates below assume that drinking fountains will be replaced with comparable types as the existing ones.
